Rimkus Consulting Group, Inc.
Eight Greenway Plaza, Suite 500
Houston, TX 77046
(800) 580-3228 Telephone
(713) 623-4357 Facsimile

Re: RCG File No: 11009971
LLV Number: 0209452
VMF Location: 1530 Greensmark Drive in Houston, Texas
Subject: Final Report

Rimkus Consulting Group, Inc. was retained to examine LLV 0209452, VIN 1GBCS10E4M2908832. The fire occurred on June 13, 2016 at around 12:30 P.M. the operator of the vehicle at the time of the fire, was unavailable for interview but reportedly stated the vehicle's engine died while delivering mail on his route and backfired during subsequent attempts to restart it. Soon thereafter, smoke was observed from beneath the hood as well as flames.

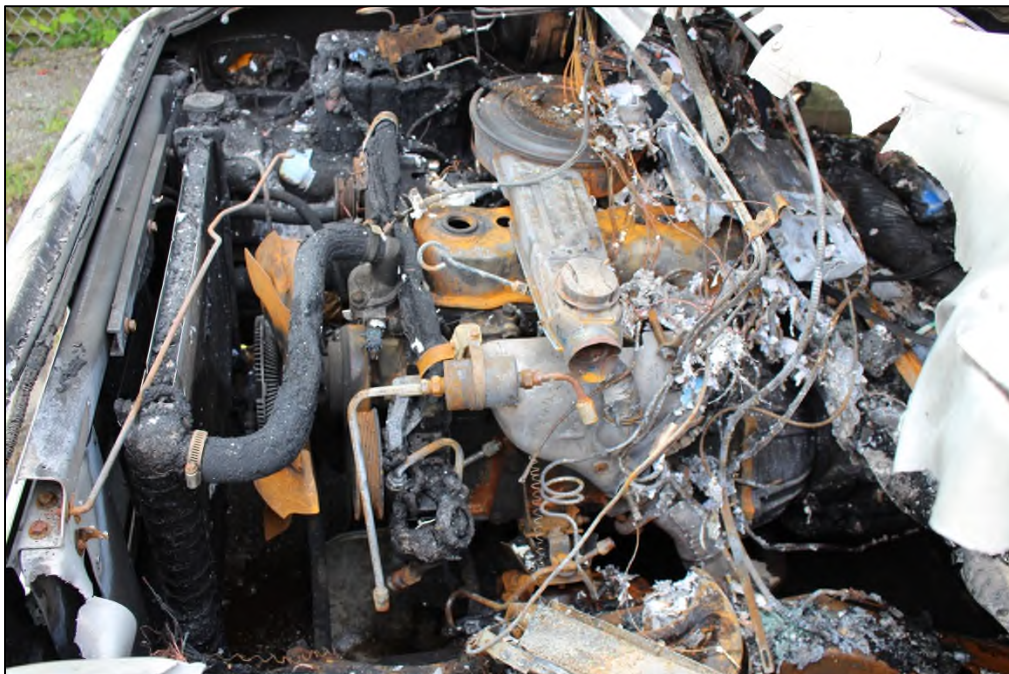
Burn pattern analysis and an examination of the remaining physical evidence within the engine compartment, revealed that fire originated on the left side of the engine, in the area of the fuel lines. The six inch rubber fuel line had been destroyed. The oil and transmission pans had been drained by VMF personel. The battery sustained moderate damage. The electrical conductors located on the left side of the engine and dashboard area were examined, and no visable adverse electrical activity was observed. The fuel filter was located on the left side of the engine in the area of the fuel lines. The engine was a 2.2 liter. There was no physical evidence observed that would indicate that the LLV was equipped with a High Energy Ignition (HEI) Distributor.

Photograph 10
Area of origin – left side.

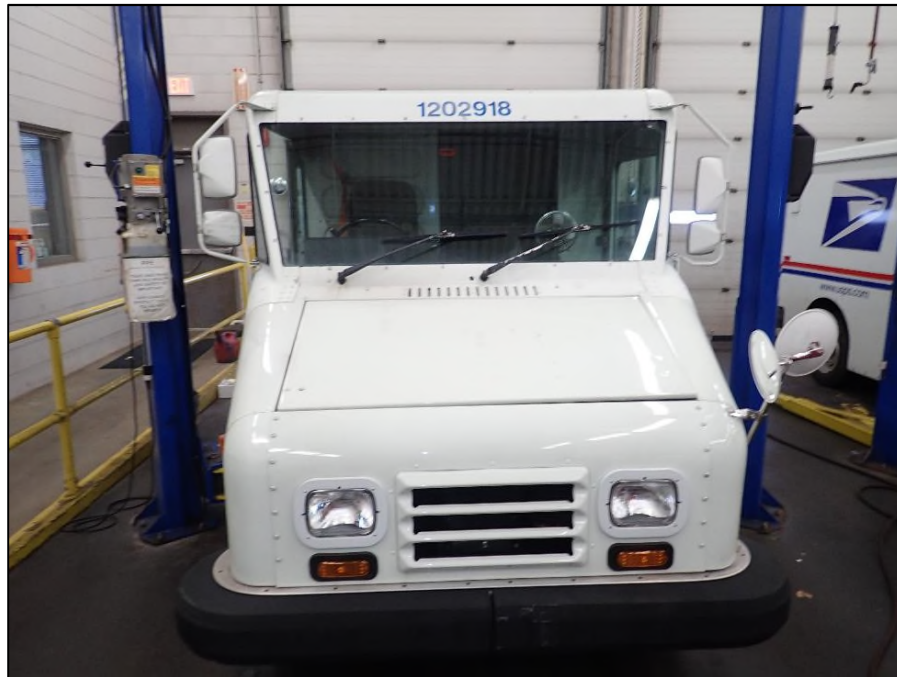
Photograph 1
Front of vehicle 1202918.

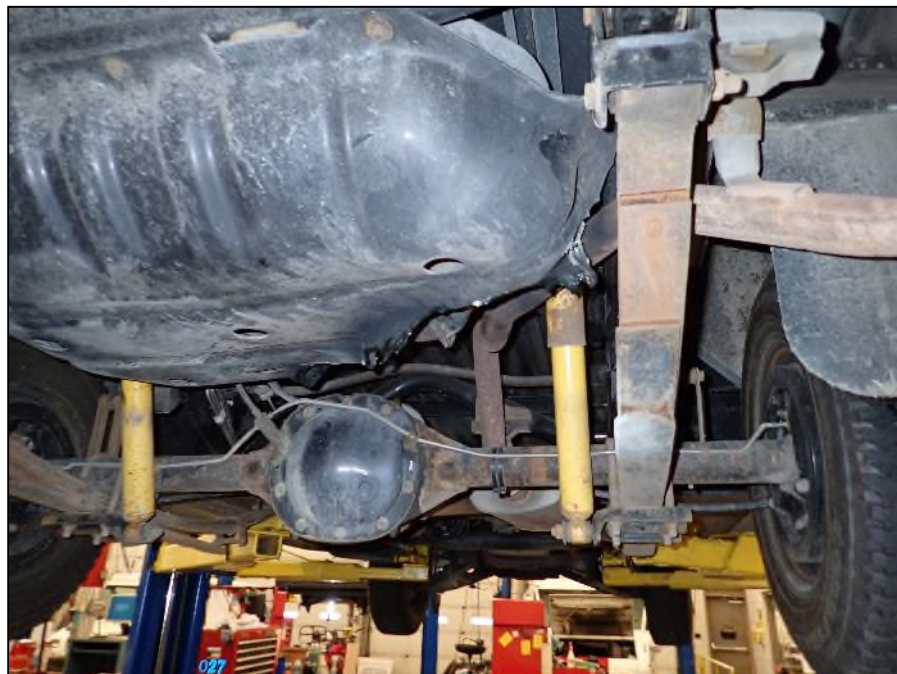
Photograph 2
View of the rear mail side undercarriage.

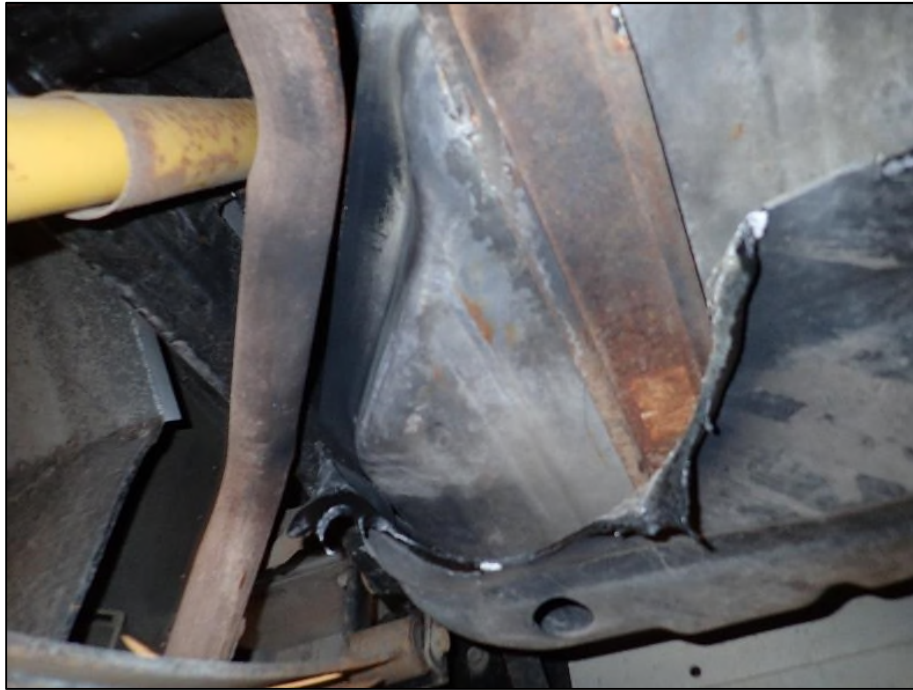
Photograph 3

View of the remains of the melted plastic shroud in proximity to exhaust pipe.

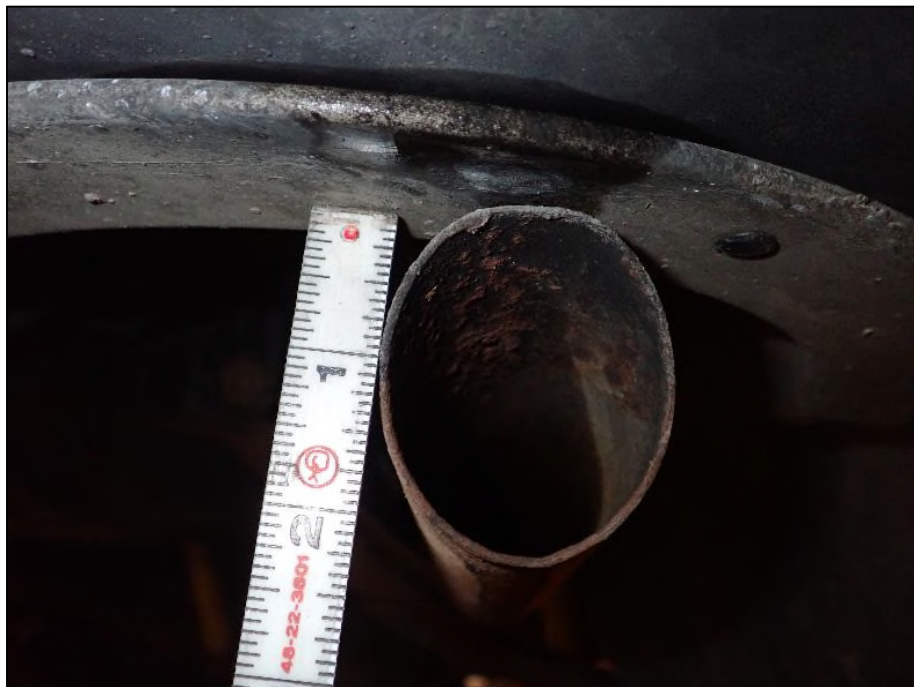
Photograph 4

View of the exhaust tailpipe in close proximity to the rear mail side bumper.

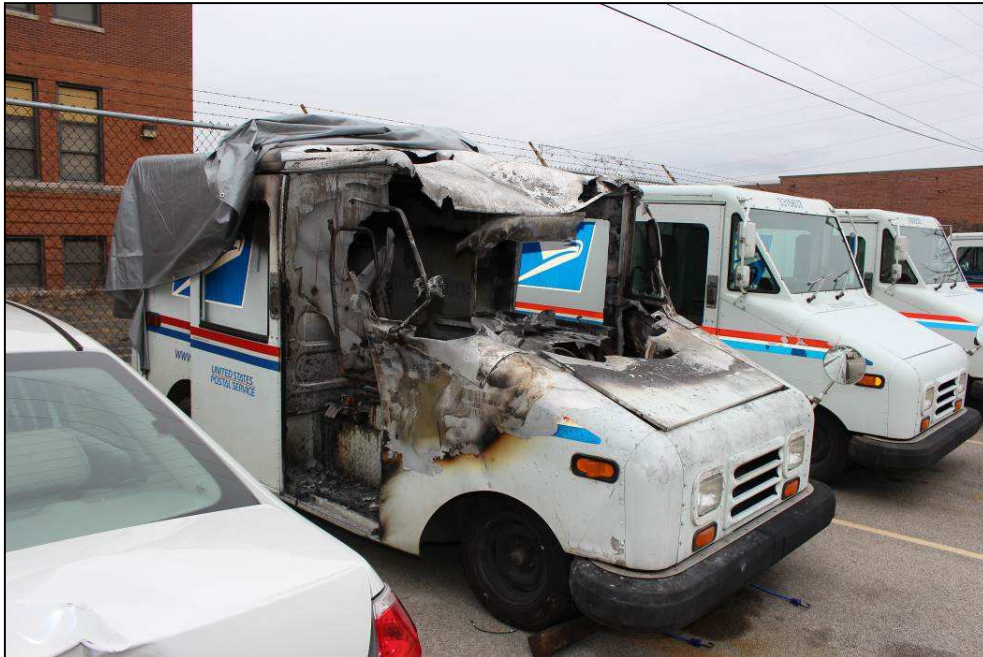
Photograph 1
Exterior view of the vehicle.

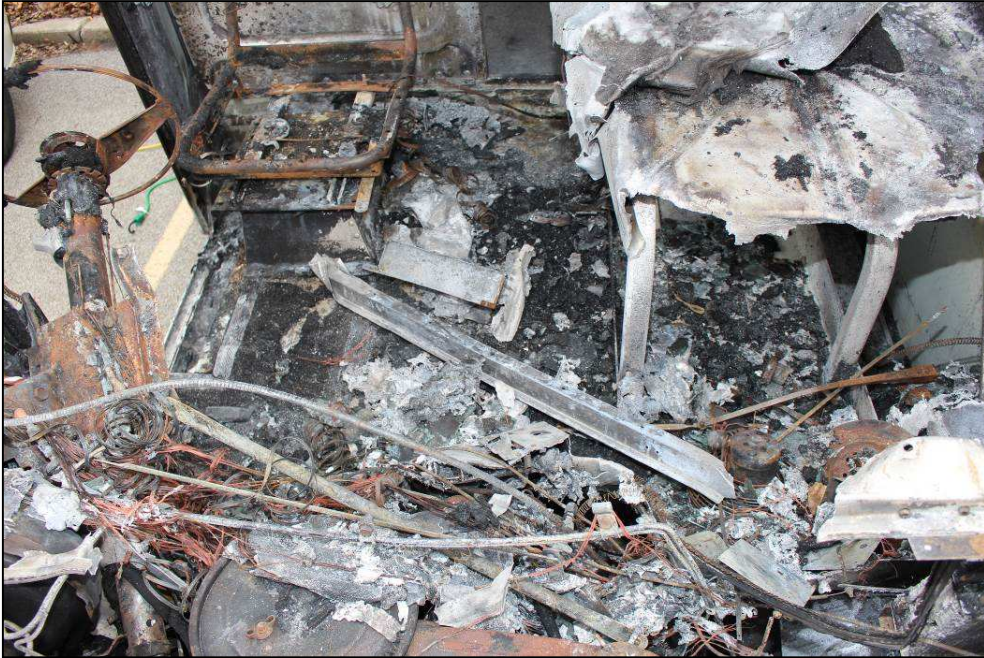
Photograph 3

View of the dash area from the front exterior.

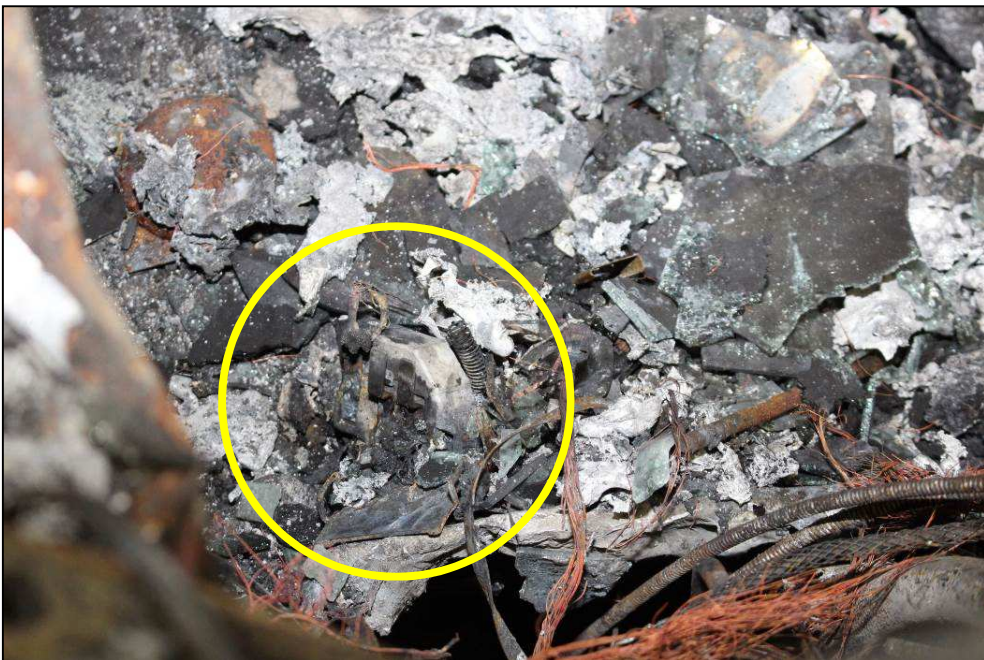
Photograph 4

Remains of the headlight control switch on the floor below the dash.

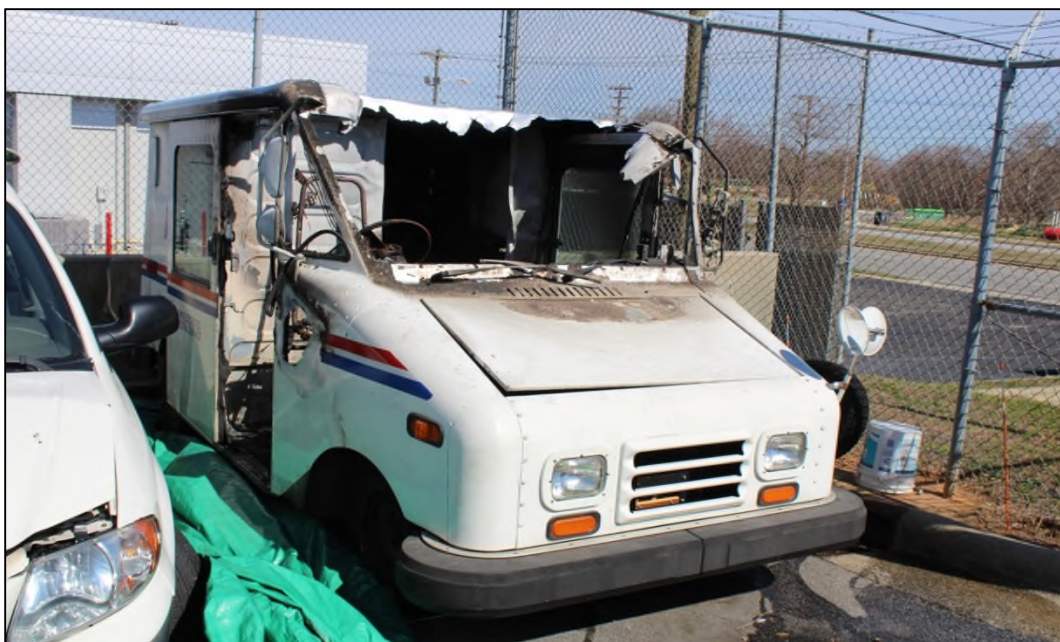
Photograph 1

1991 Chevrolet LLV 1253603, VIN 1GBCS10A5M2922221.

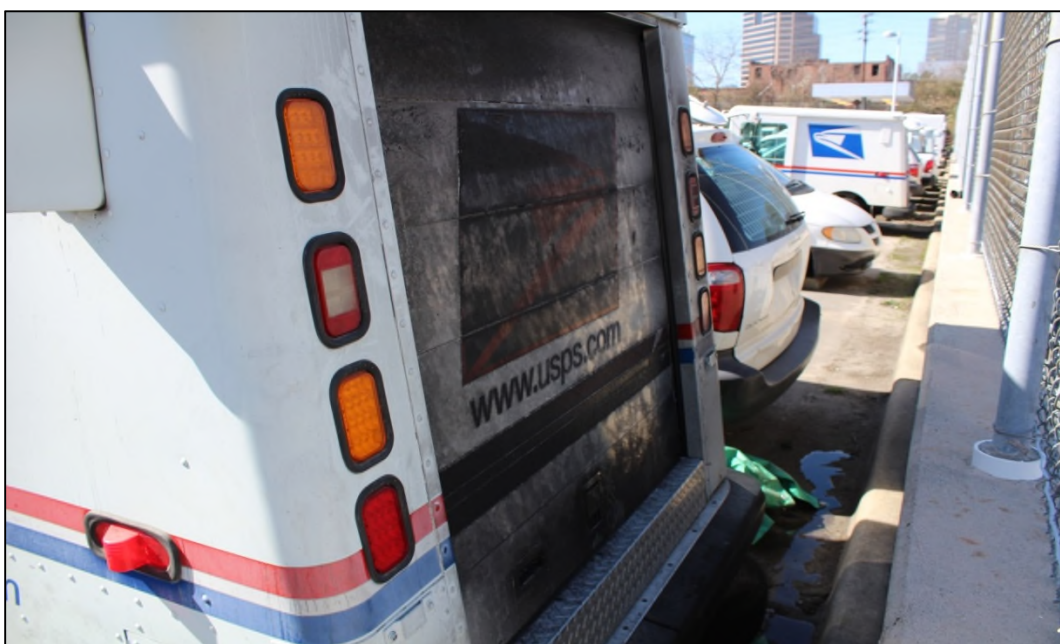
Photograph 2

Rear of vehicle.

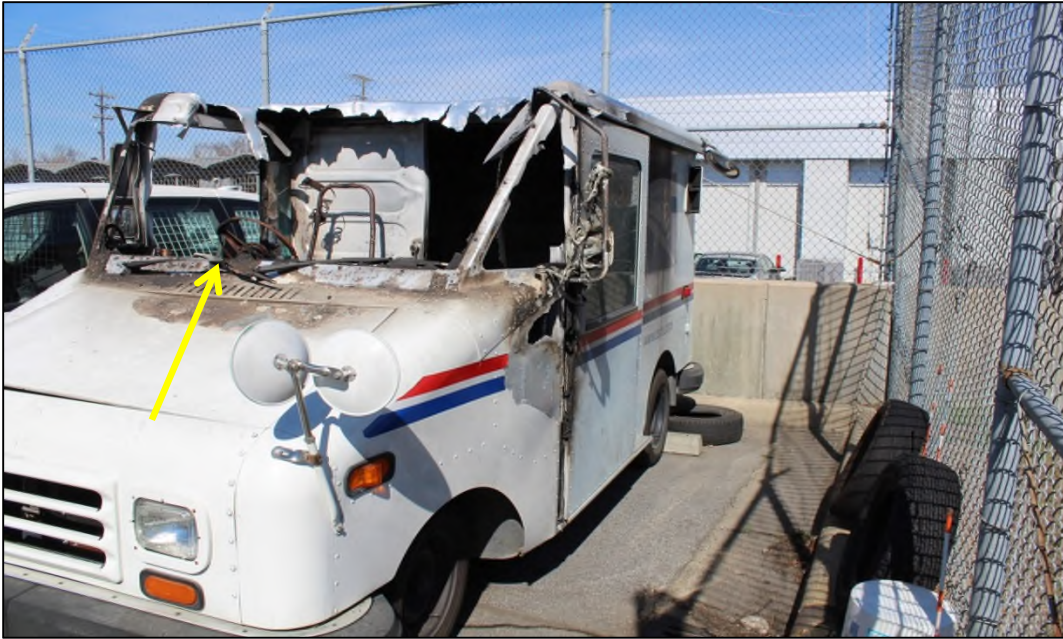
Photograph 3

Left side of vehicle. Arrow indicates severe fire damage to the dashboard area.

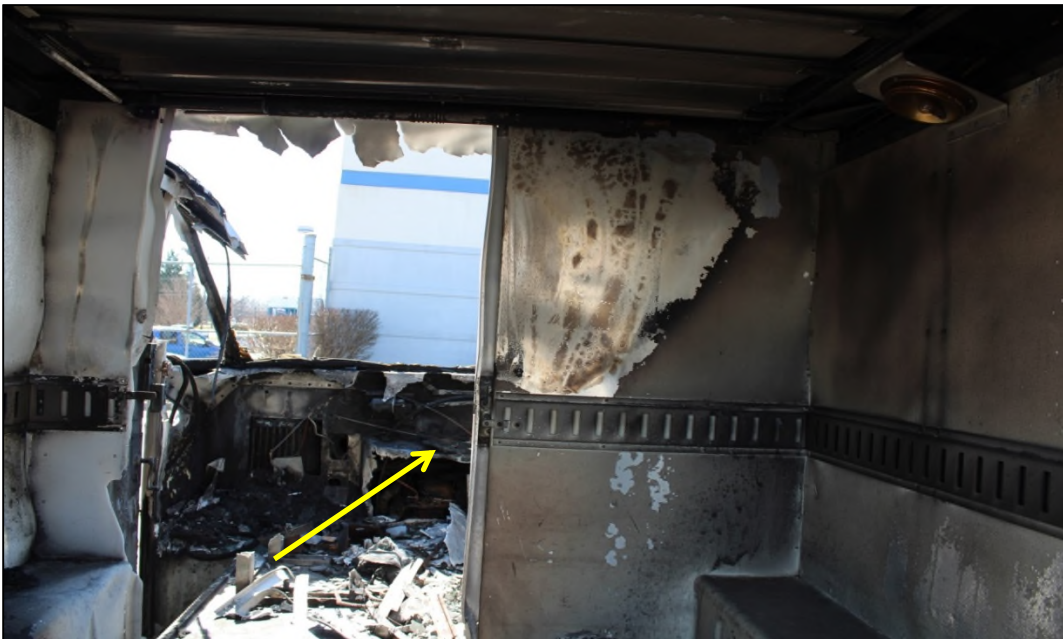
Photograph 4

Rear cargo area. Arrow indicates progression of the burn patterns extending from the passenger compartment area toward the rear cargo area.

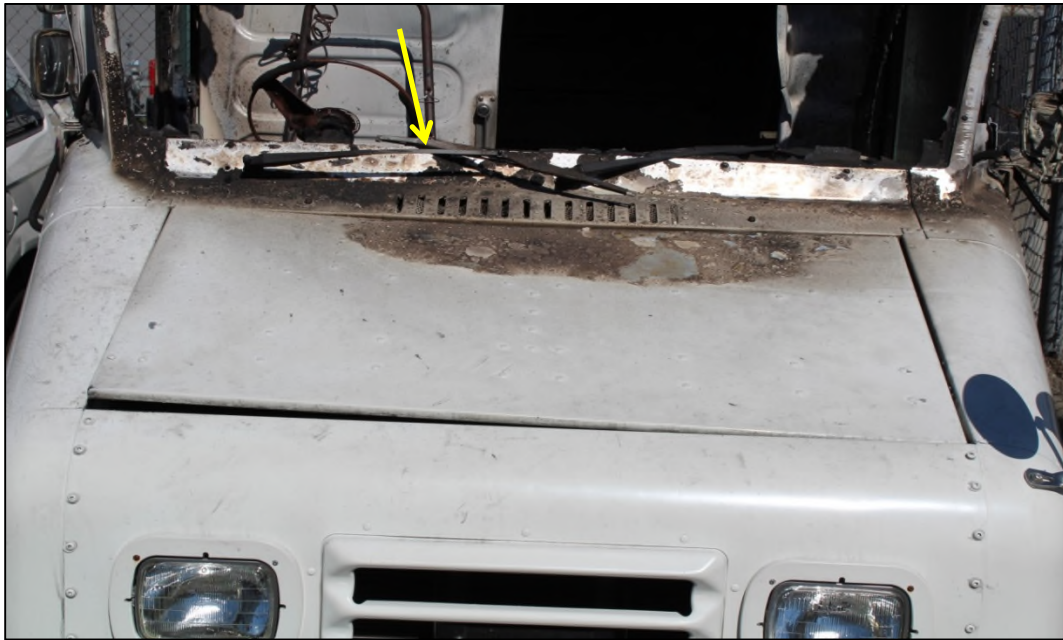
Photograph 5

The engine compartment hood assembly. Arrow indicates progression of the burn patterns extending from the dashboard area.

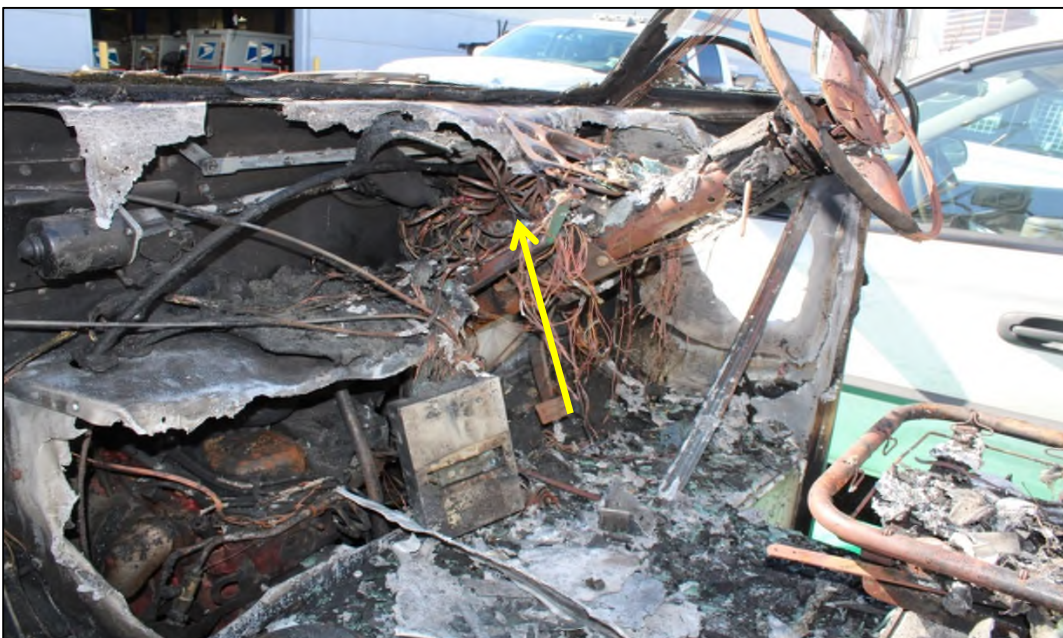
Photograph 8

The dashboard area and steering column. Arrow indicates most severe fire damage progression from the location the headlight switch was located.

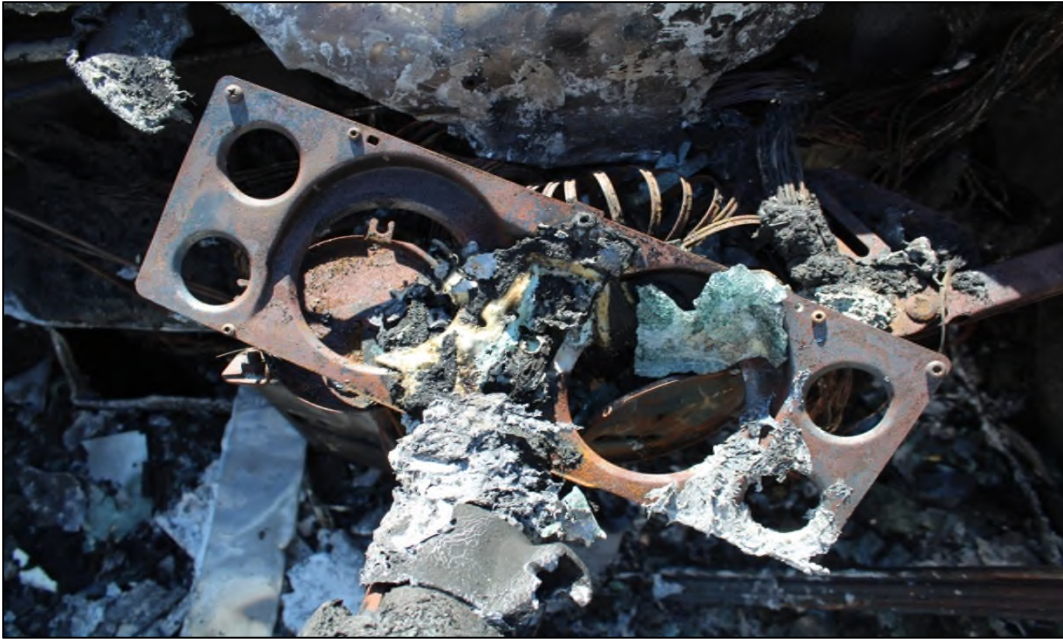
Photograph 9

The remains of the dashboard and gauge cluster assembly.

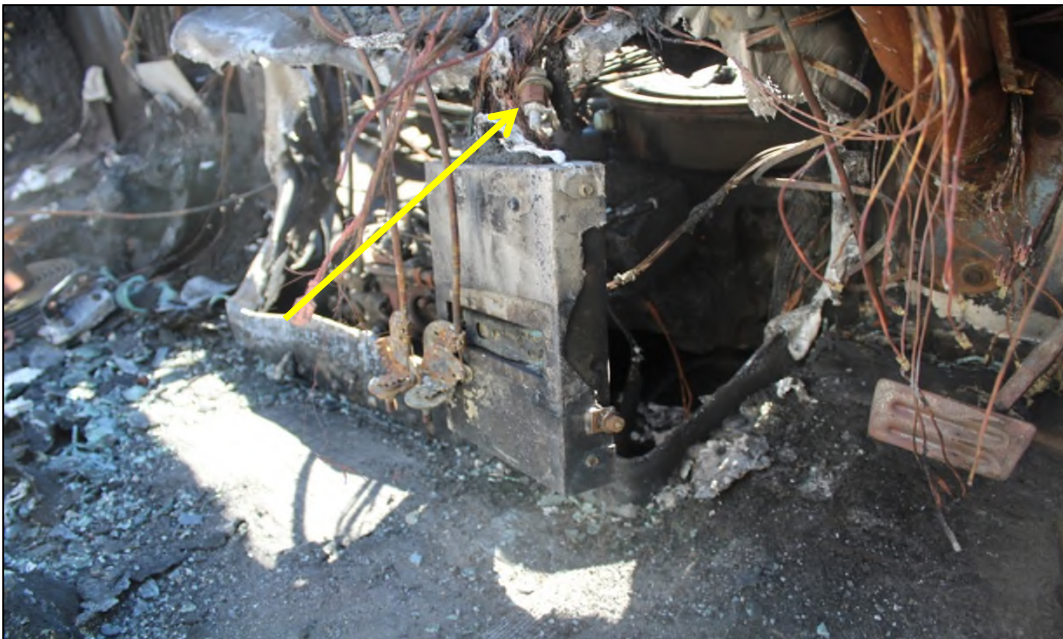
Photograph 10

The floor board and lower dashboard in front of the driver's seat. Arrow indicates the more severe fire damage is high on the dash and lower portions are less severe.

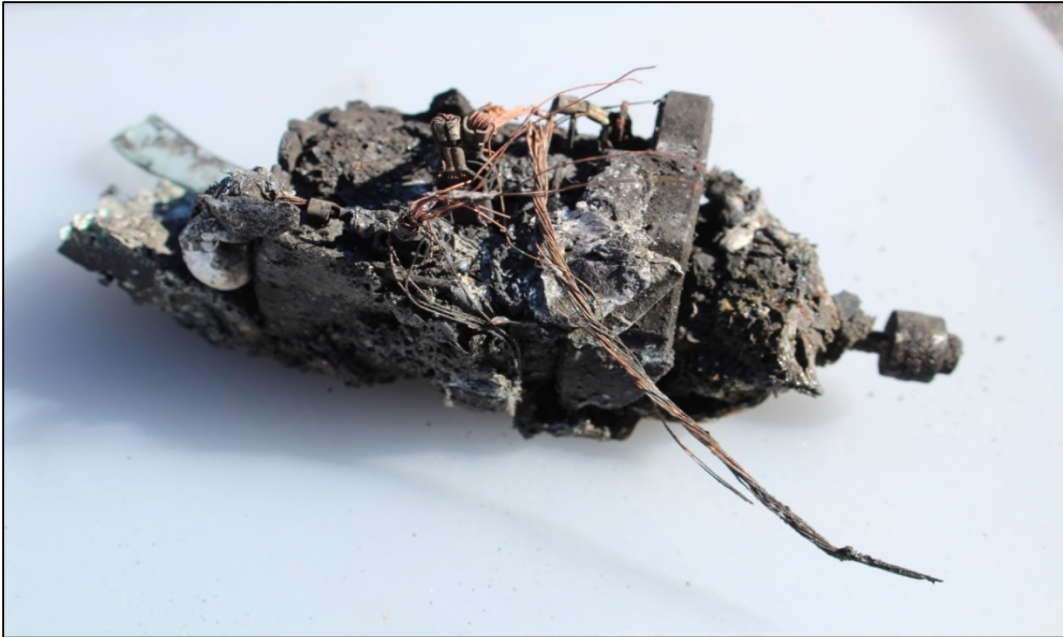
Photograph 11

The remains of the headlight switch assembly.

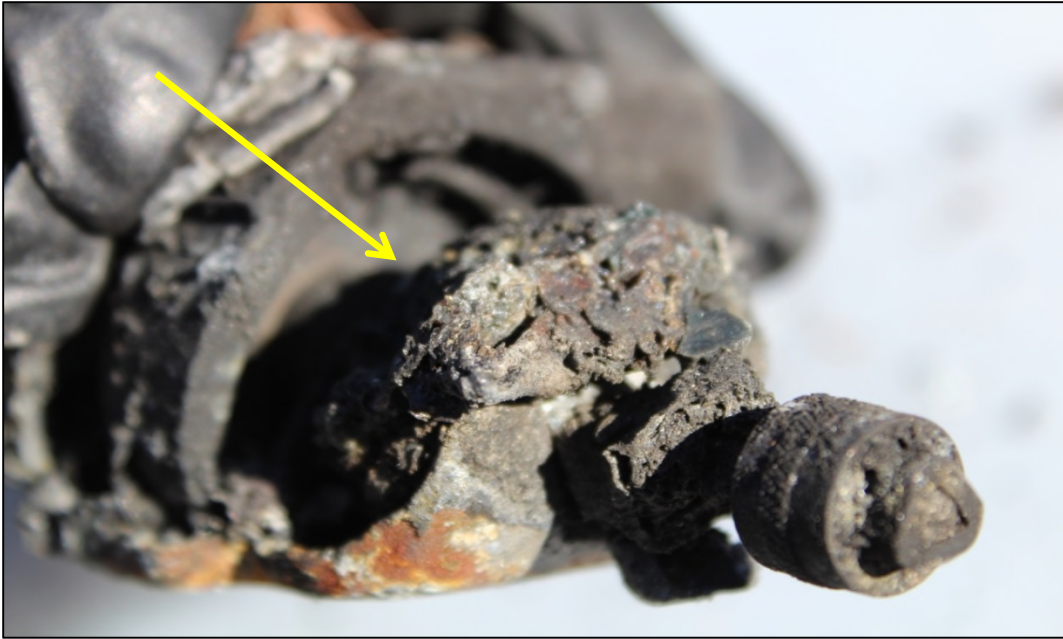
Photograph 10

The front of the switch and the coil spring damage.

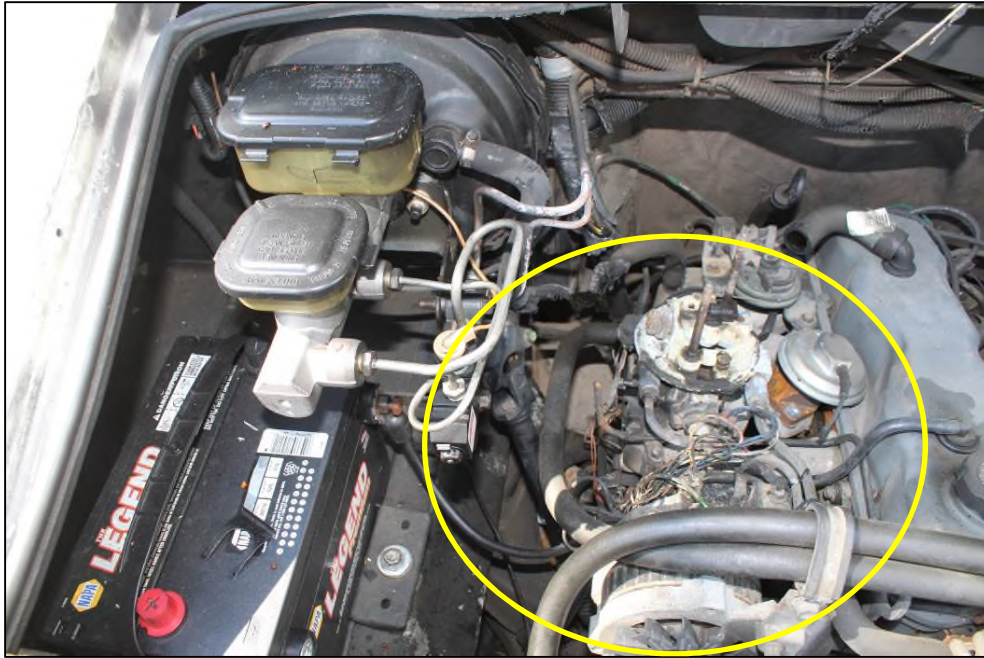
Photograph 3

View of the fire damage to the engine compartment.

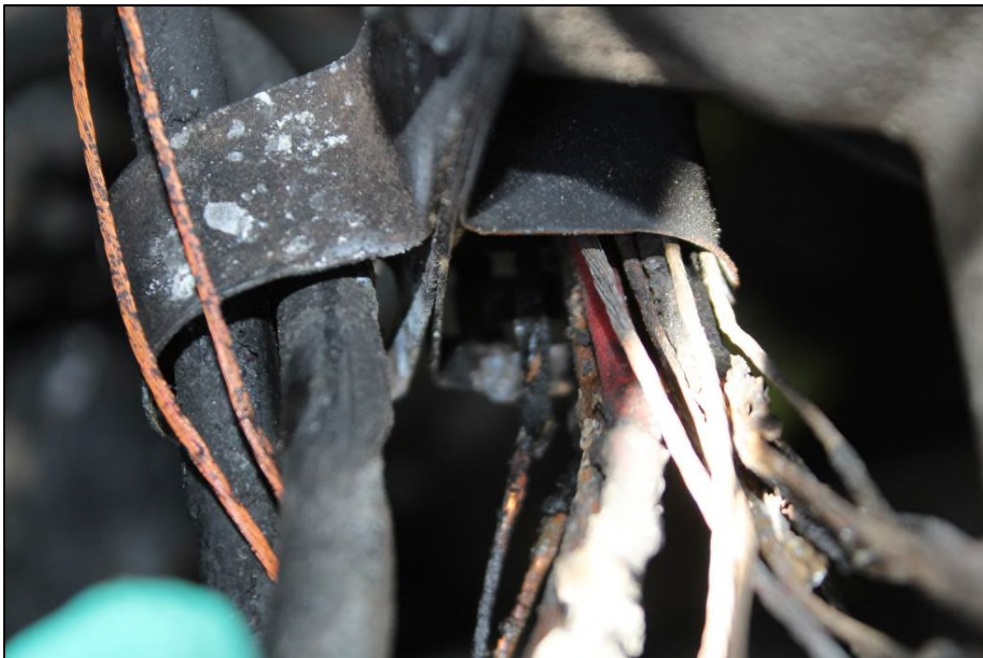
Photograph 4

3. The specific ignition sequence and cause of the fire was determined to be an adverse electrical event at the wiring harness cable that was routed through a retaining clamp (P-clip) at the right side of the engine. The cable exhibited physical evidence consistent with adverse electrical activity and the cable was severed at the retaining clamp. The retaining clamp exhibited physical evidence consistent with adverse electrical activity and contact arcing. The source of the fire's ignition was caused by contact arcing between the energized cable and the metal retaining clamp.
4. Wear and degradation of the components allowed an unfused adverse electrical event to develop at the energized cable that connected to the engine starter where it was in direct contact with the metal retaining clamp at the right side of the engine compartment.

The specific ignition sequence and cause of the fire was determined to be the direct result of an electrical conductor being chaffed and worn causing the exposure of the

Wear and degradation of components allowed an adverse electrical event to develop at the wiring harness where it was in direct contact with the retaining clamp at the right side of the engine.

View of the damaged conductors at the P-clip.

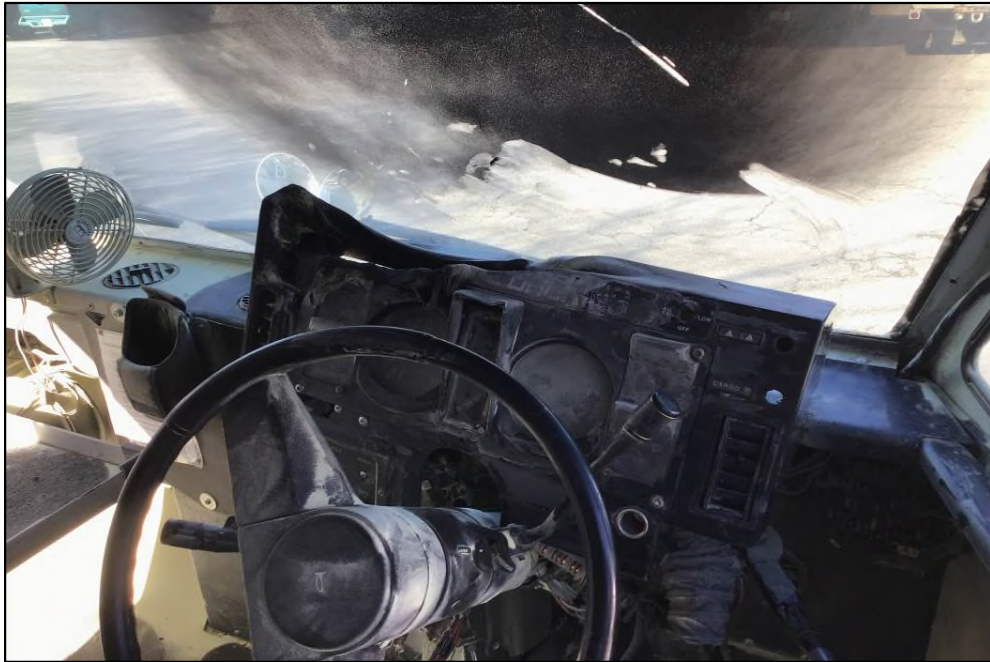
Photograph 3

Dashboard was determined to be the area of fire origin. Dash replaced in original location.

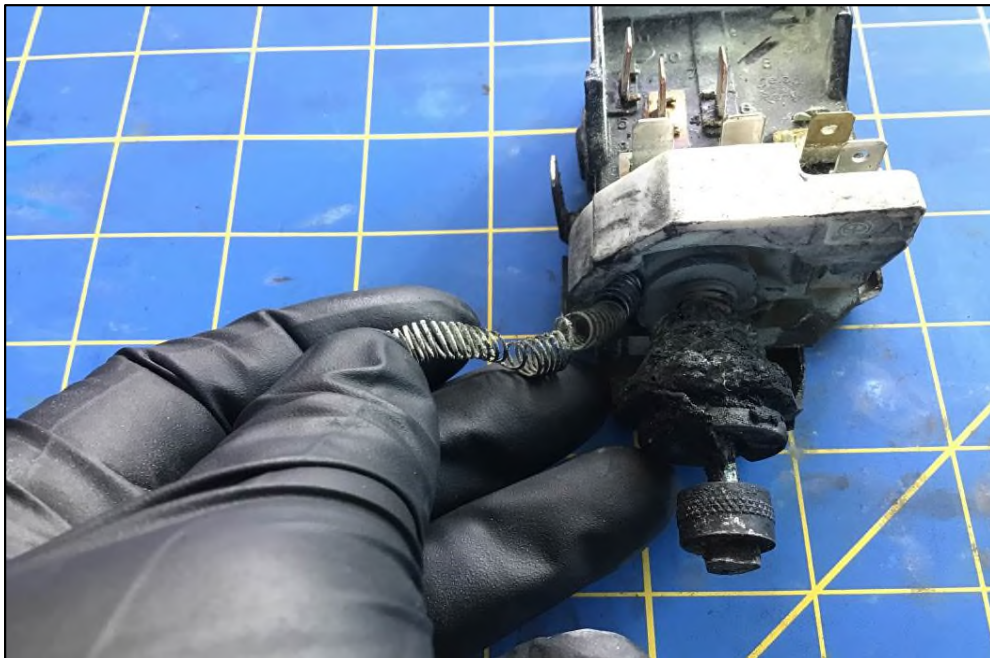
Photograph 4

Remains of headlight switch.

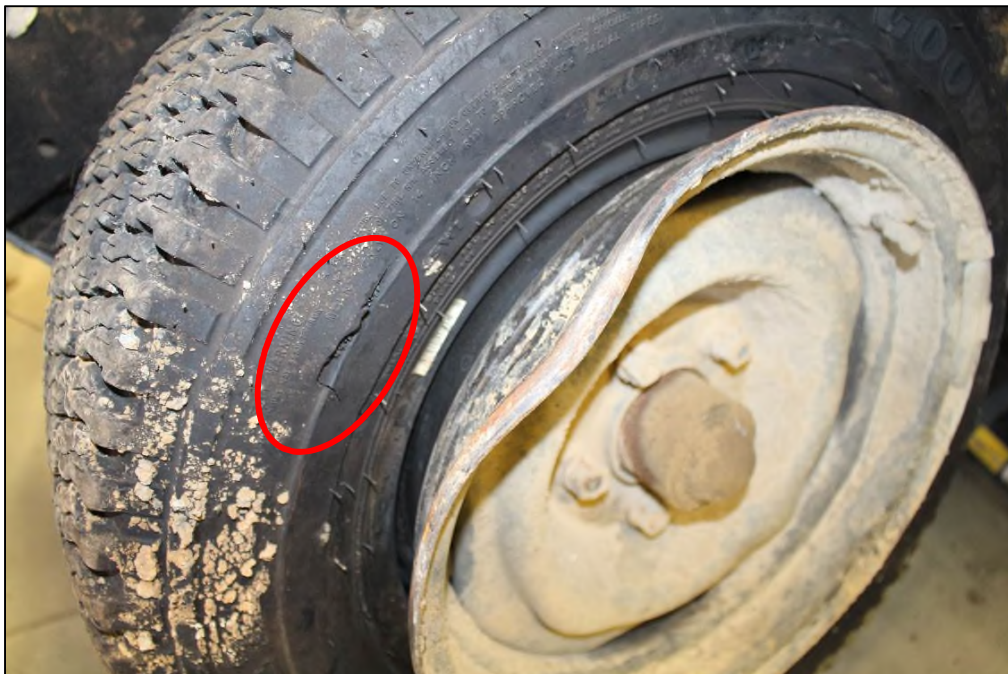
Photograph 3

View of the damaged front left tire and wheel.

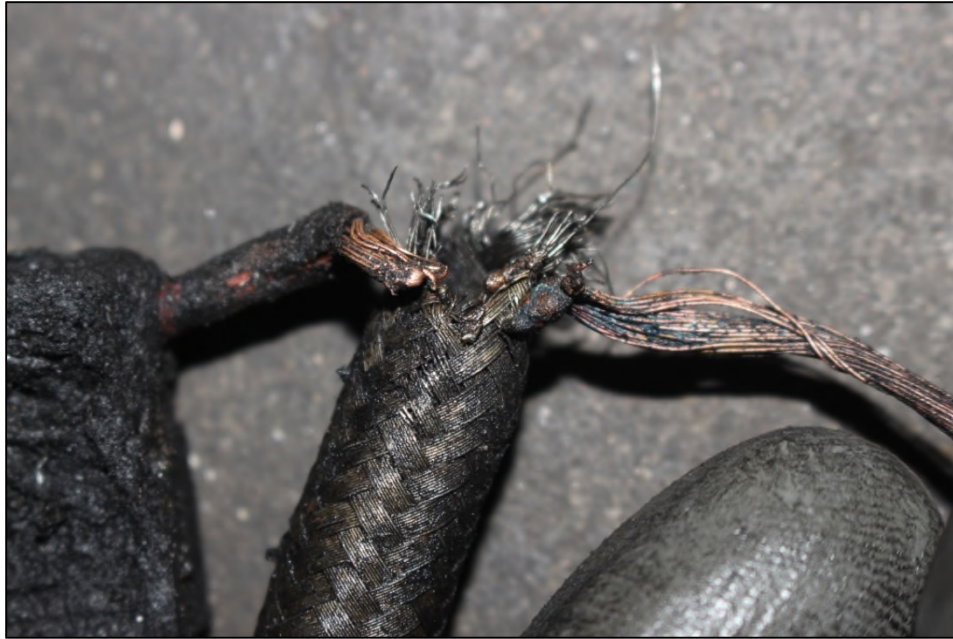
Photograph 3

Electrically severed conductor and oil line. In-line fuse holder, left.

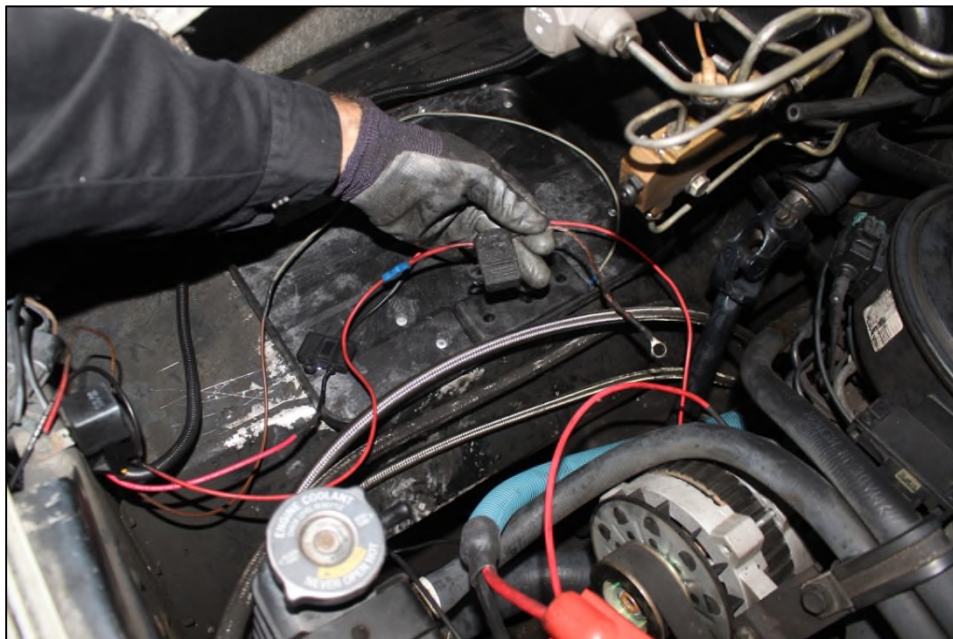
Photograph 4

Severed conductor repositioned at origin area.

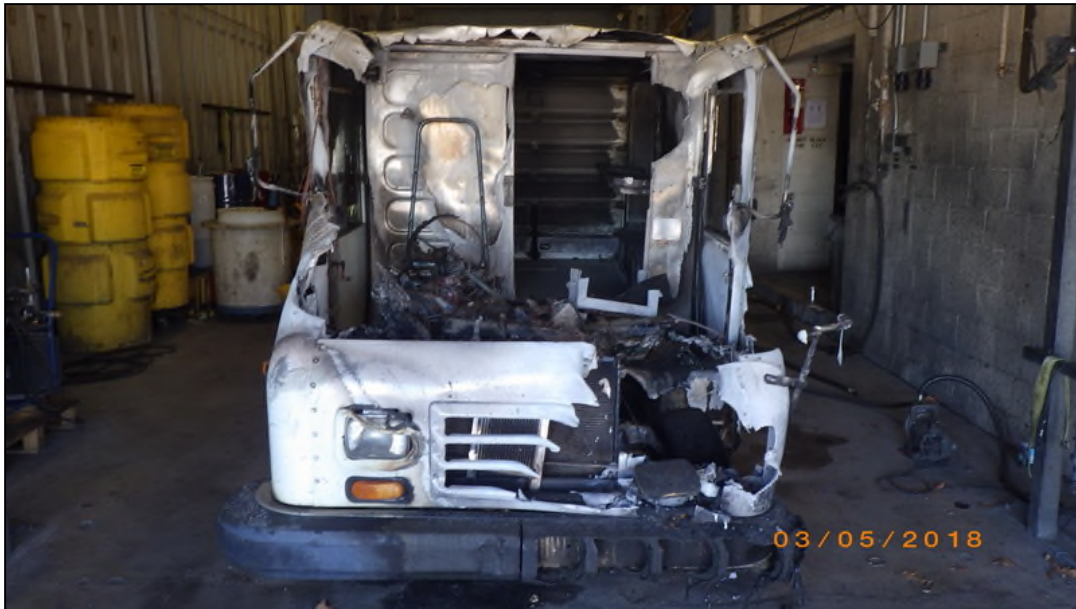
Photograph 1

A view of the exterior front of the vehicle.

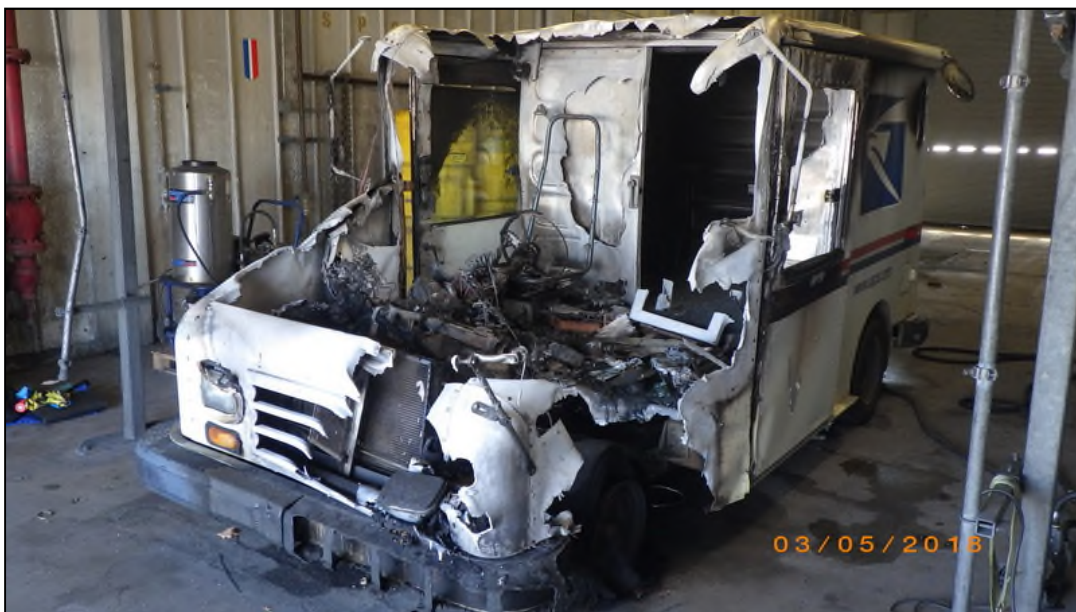
Photograph 2

The exterior left side sustained fire and heat damage from the front bumper to the sliding door. The sliding door and rear panel sustained fire, heat and smoke damage to the upper portion. The front fender had been consumed above the engine and the front portion of the left wheel and tire. The exterior rear sustained smoke damage to roll up door and bulkhead. The exterior right side sustained fire, heat and smoke damage to the upper portion of the rear side panel and to the driver door. The front fender had sustained the most severe damage above the right front wheel and tire. The roof had been consumed above the driver's compartment. It was intact above the cargo area.

A view of the exterior left side of the vehicle.

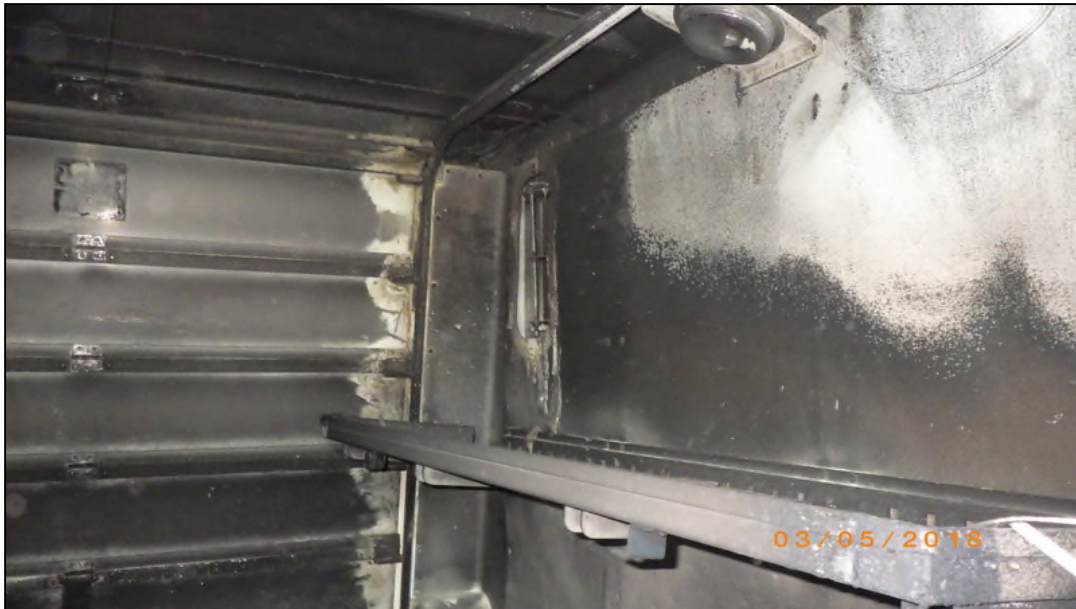
Photograph 5

The cargo area sustained smoke damage throughout. The left side panel sustained the most severe damage. The driver's compartment sustained fire and heat damage throughout. The combustible material of the driver's seat had been consumed. The

A view of the interior cargo area.

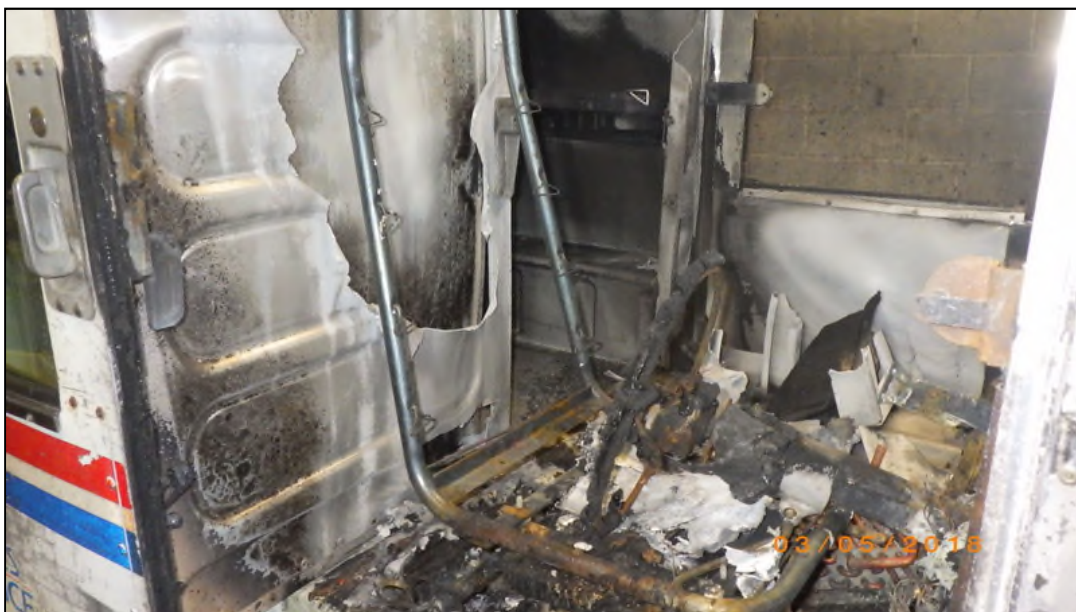
Photograph 6

top portion of the mail rack along the left side had been consumed. The steering column had collapsed. The front bulkhead had been consumed. The fuse block located on the right side of the driver's compartment had fallen into the engine compartment and was too severely damaged by the fire to be evaluated. The ignition was too severely damaged to be evaluated. The headlight switch had fallen to the floor. It displayed no evidence of adverse electrical activity. Two conductors within the dashboard wiring harness displayed beading. The heater fan and ventilation fan sustained fire and heat damage and had become dislodged. An aftermarket radio sustained fire and heat damage and had become dislodged.

A view of the interior driver's compartment.

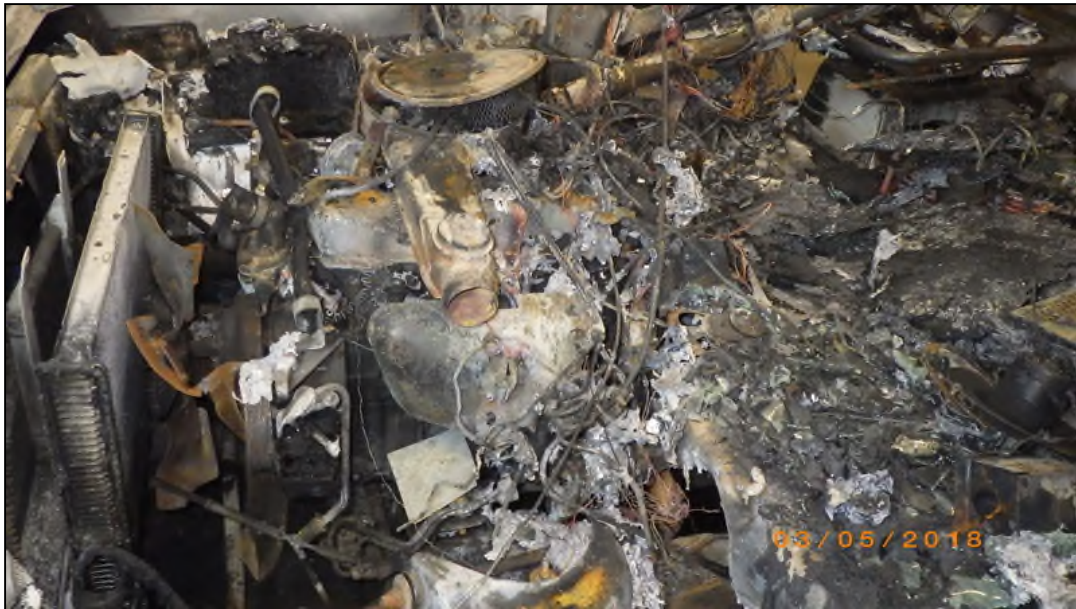
Photograph 7

Burn pattern analysis and an examination of the remaining physical evidence within the engine compartment revealed that the fire originated within the engine compartment. The vehicle was equipped with a GM 2.5L, four-cylinder gasoline engine. The engine compartment sustained severe fire, heat, and smoke damage throughout. The damage was most severe on the left side of the engine compartment. The power steering unit sustained fire damage. The reservoir had been consumed. The upper portion of the flexible return line and reservoir had been consumed. The upper radiator hose on the left side of the engine compartment had been consumed.

A view of the engine compartment.

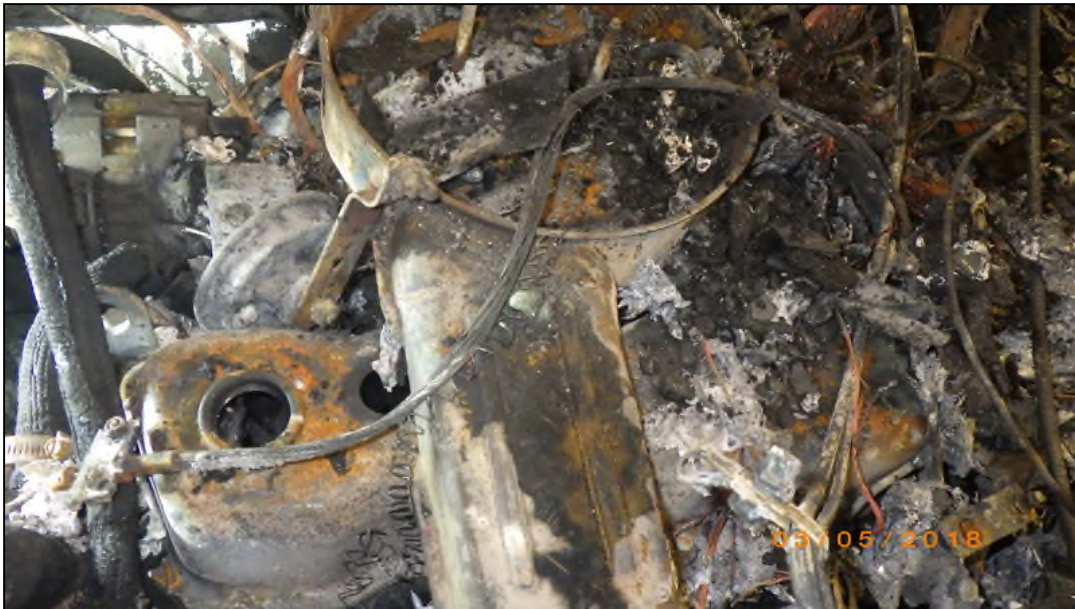
Photograph 9

The top and side nearest to the engine of the battery case had been consumed. The conductors had become detached from the side terminals. The negative conductor was attached to the frame and to the block. The main positive conductor was attached to the starter. The insulation had been consumed but displayed no evidence of adverse electrical activity. The radiator was intact except at the top right corner. The air breather was in place but the air filter had been consumed. The distributor sustained fire and heat damage.

A view of the air filter area.
